# Florida Oyster Cultch Placement Project

## Year Two Monitoring Report

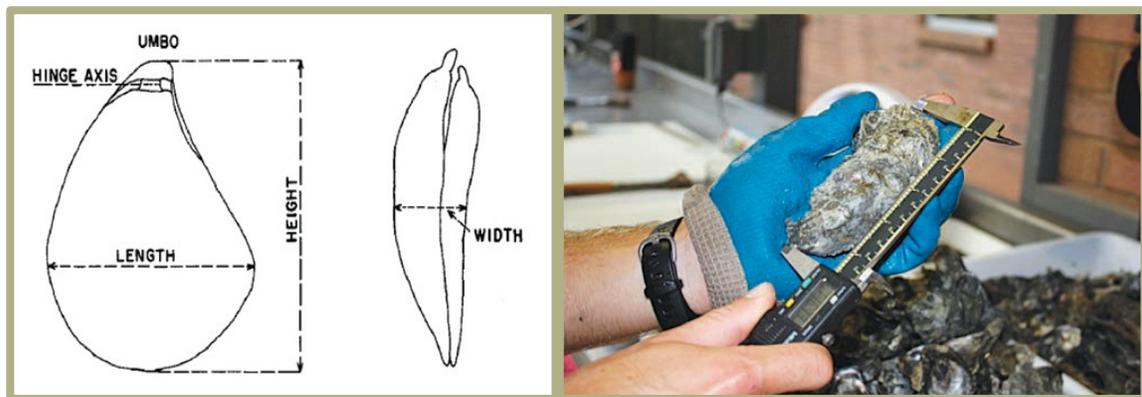
Figure 1: (left) Diagram of the height, length, and width measurements of an oyster shell, from Galtstoff 1964, Chapter 2. (right) An example of shell height measurement in a lab.

First, the sample is weighed using a digital hanging scale. If oysters are present in the collected sample, shell height of the first 100 live oysters is measured to the nearest millimeter (mm). Oyster shell height (Figure 1) is defined as the distance from the umbo to the distal margin of the shell (Bagget *et al*, 2014).

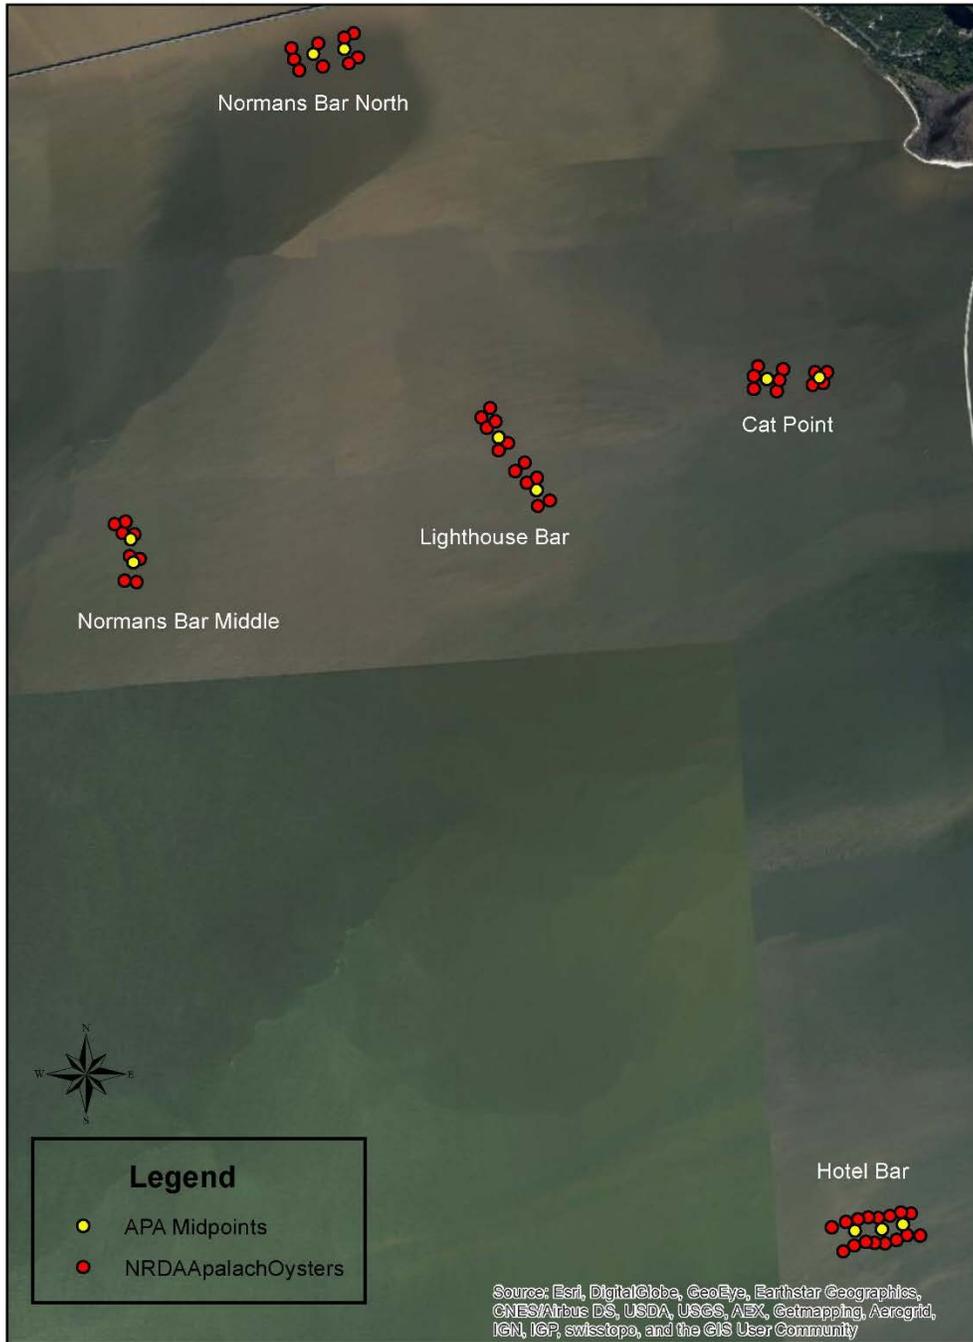
Figure 4: Apalachicola Bay Sites with Midpoints in the East region of the bay.

#### **East Side (Figure 4)**

Apalachicola Bay NRDA Oyster Cultch Placement sites were sampled during April – July 2017 (Round 1), December 2017 – April 2018 (Round 2), and September – December 2019 (Round 3). A total of 16 reef sites consisting of 28 midpoints were sampled during each round (see Table 2 and Figures 3 & 4).

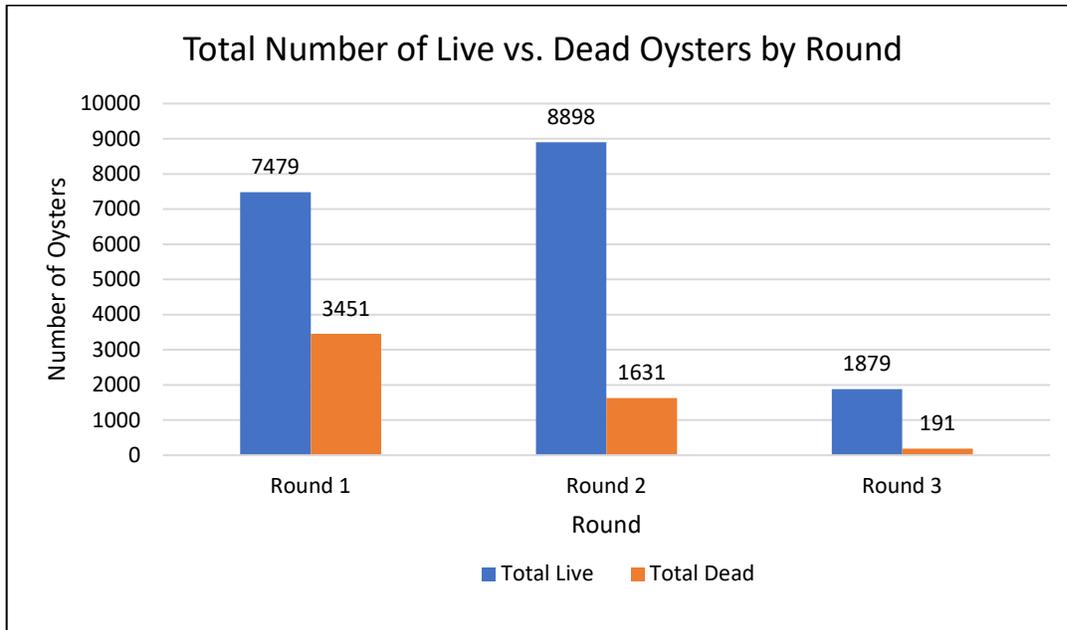
Figure 5: Total number of live vs. dead oysters by sampling round.

live oysters collected per sample showed that the decrease in live oysters from Round 1 and Round 2 were both statistically significant ( $p=3.79 \times 10^{-18}$  and  $p=2.81 \times 10^{-13}$ , respectively). A decrease in dead oysters sampled was also observed from Round 1 ( $n=3451$ ) to Round 3 ( $n=191$ ) and Round 2 ( $n=1631$ ) to Round 3. The decreases in dead oysters observed per sample from Round 1 and Round 2 were also found to be statistically significant ( $p=1.66 \times 10^{-21}$  and  $7.29 \times 10^{-25}$ , respectively).

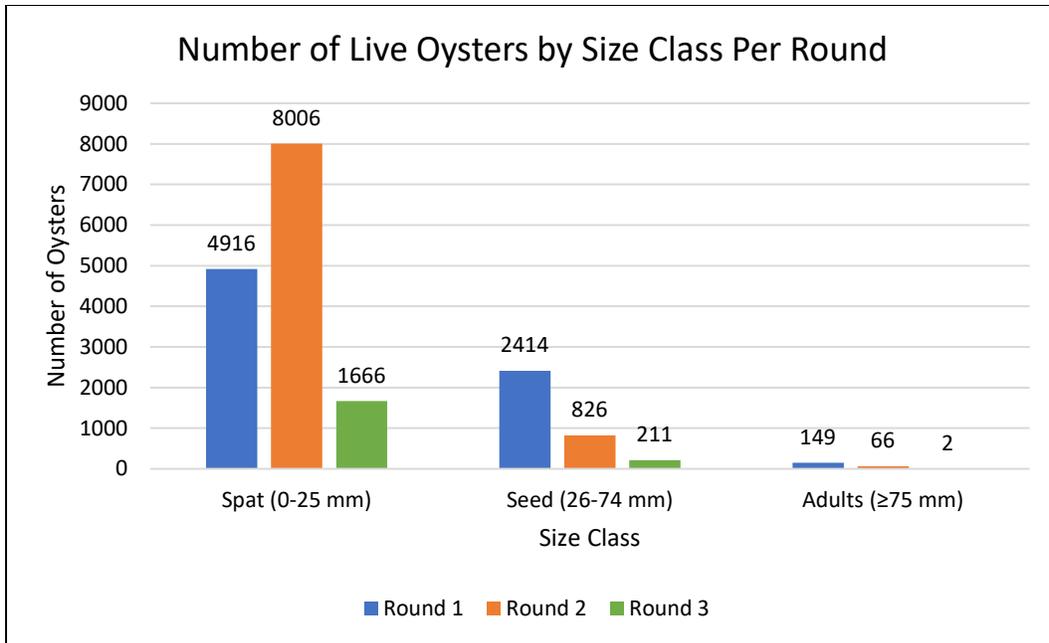
Figure 6: Number of live oysters by size class per sampling round.

A comparison of size classes among live oysters showed that spat-sized oysters continued to be the most prevalent size class in all sampling rounds, representing approximately 79.91% of total live oysters processed to date and roughly 88.66% of total live oysters processed during Round 3 of sampling (Figure 6). Adult-sized, harvestable oysters continued to represent the least abundant size class. Statistically significant decreases in live oysters sampled were observed across all size classes (spat, seed, and adult) from Round 1 to Round 3 ( $p=8.31 \times 10^{-11}$ ,  $p=2.09 \times 10^{-12}$ , and  $p=1.81 \times 10^{-9}$ , respectively). Significant decreases were also observed across all size classes from Round 2 to Round 3 ( $p=4.45 \times 10^{-12}$ ,  $p=6.05 \times 10^{-9}$ , and  $p=7.09 \times 10^{-6}$ , respectively).

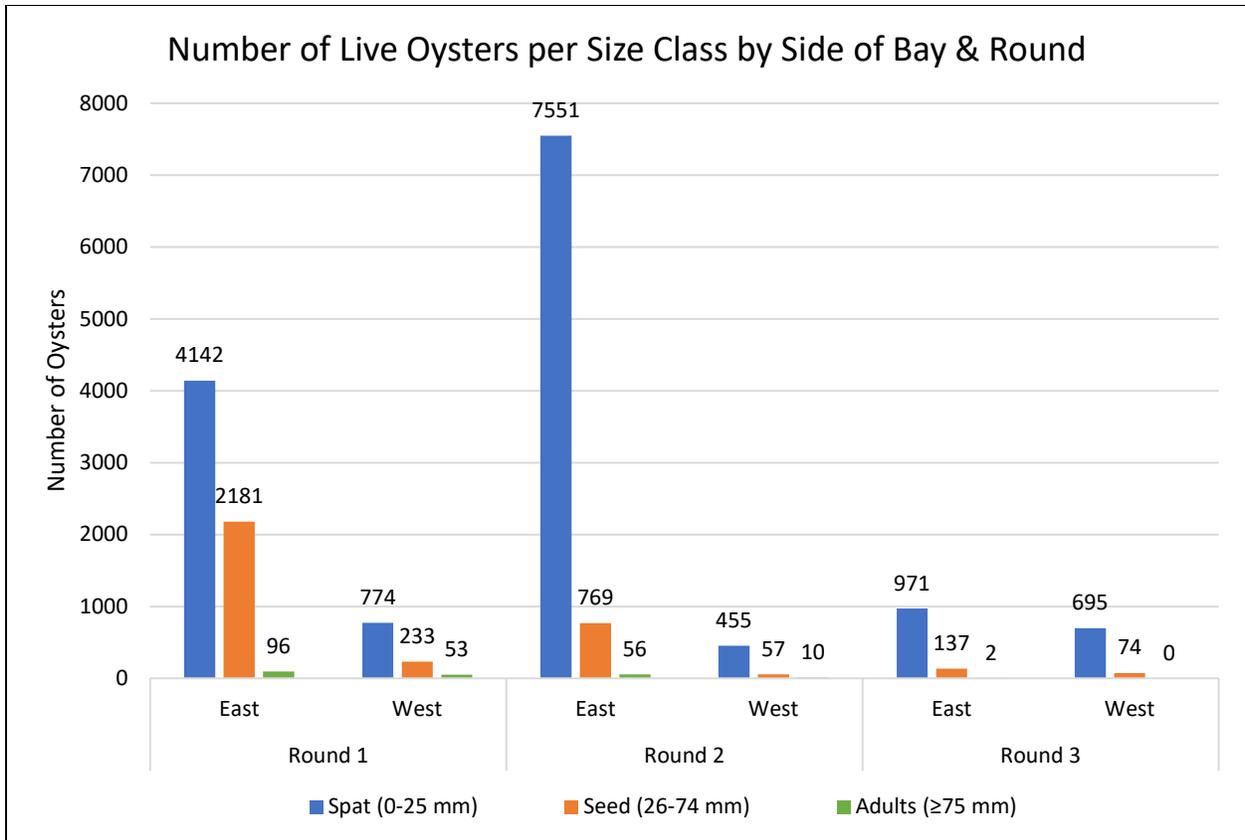
Figure 7: Number of live oysters per size class by side of bay and sampling round.

For all rounds of sampling, the East side of the bay contained more live oysters across all size classes than the West side (Figure 7). The number of spat-sized oysters on the East side nearly doubled from Round 1 to Round 2, but drastically decreased from Round 2 to Round 3, with only 971 spat sampled. Both seed-sized and adult-sized oysters have continued to decline on the East side of the bay. The only adult-sized, harvestable oysters collected during Round 3 sampling were found on the East side of the bay, at Norman’s Bar North (n=2). The number of spat-sized and seed-sized oysters increased slightly from Round 2 to Round 3 sampling on the West side of the bay. However, a decrease in adult-sized oysters was observed from Round 2 to Round 3, as no adult oysters were present in samples collected from the West side of the bay during Round 3. Decreases in number of live oysters across all size classes were observed on the West side when comparing Round 3 to Round 1.

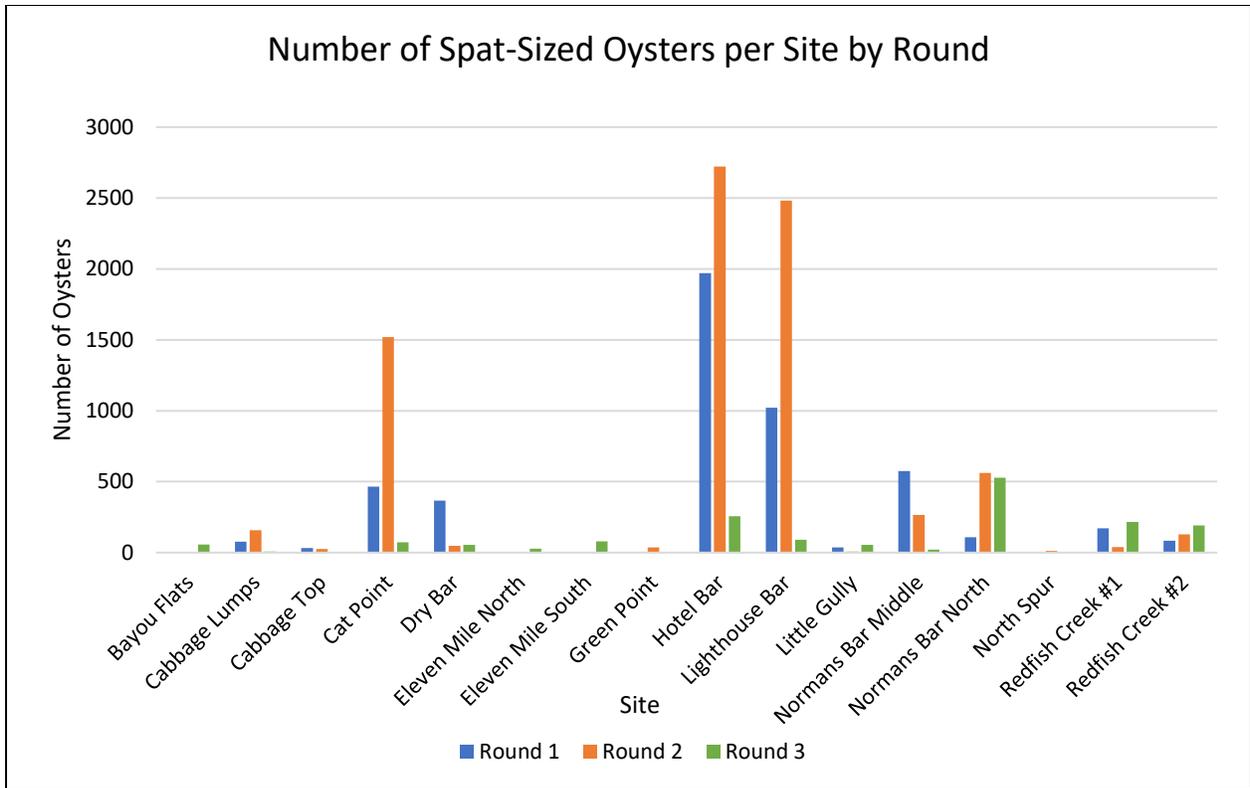
Figure 8: Number of spat-sized oysters per site by round.

When analyzed by site, nine of the 16 sampling sites (Cabbage Lumps, Cabbage Top, Cat Point, Green Point, Hotel Bar, Lighthouse Bar, Norman's Bar Middle, Norman's Bar North, and North Spur) saw a decrease in the number of spat-sized oysters collected from Round 2 to Round 3, which includes all sites on the East side of the bay. The most notable decreases were observed at Hotel Bar, Lighthouse Bar, and Cat Point. (Figure 8).

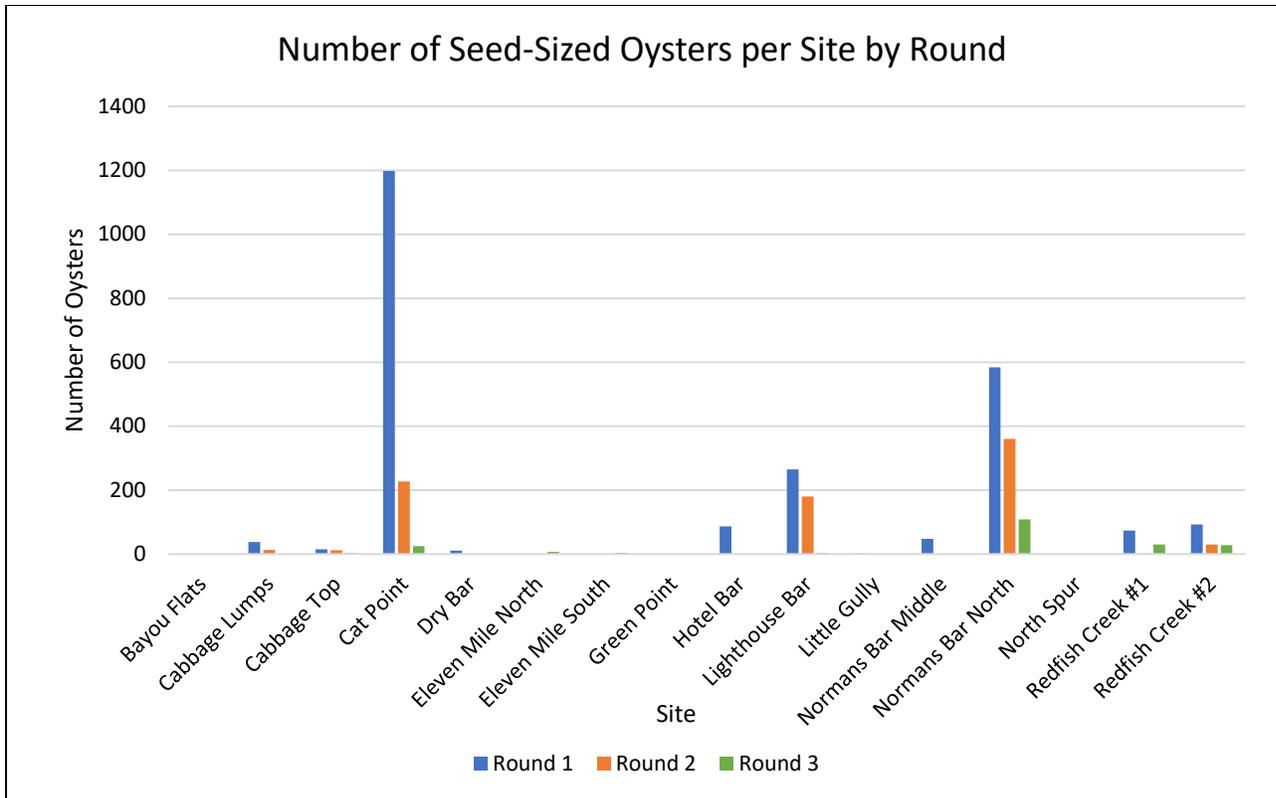
Figure 9: Number of seed-sized oysters per site by round.

The majority of sites in Apalachicola Bay saw a decrease in seed-sized oysters sampled from Round 2 to Round 3. (Figure 9). More than half (51.18%) of the total seed-sized oysters sampled during Round 3 were collected from one site, Norman’s Bar North; however, the number of seed collected from this site decreased by 70% from Round 2 (n=360) to Round 3 (n=108). Five of the sites (Bayou Flats, Green Point, Little Gully, Norman’s Bar Middle and North Spur) contained zero seed-sized oysters in Round 3 samples.

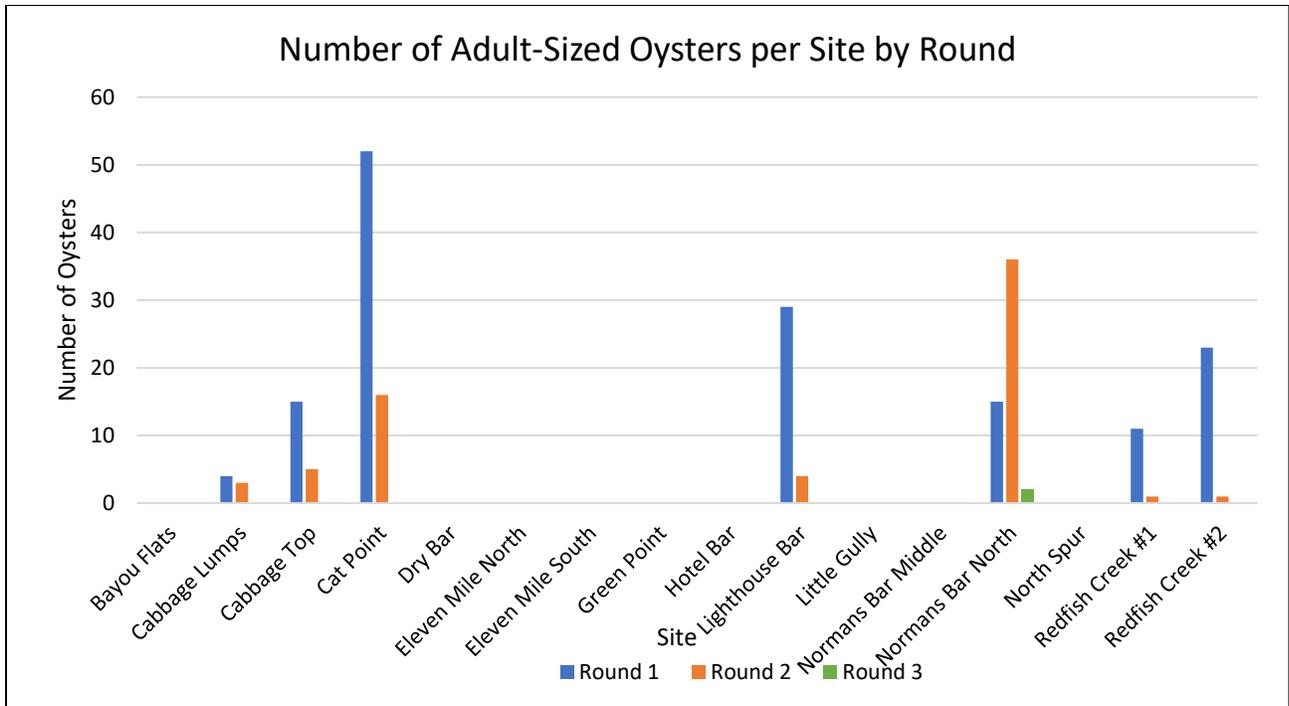
Figure 10: Number of adult-sized oysters per site by round.

Norman’s Bar North was the only site that had adult-sized oysters present in Round 3 (n=2), which is less than the number of adult oysters sampled at Norman’s Bar North in Round 1 (n=15) and in Round 2 (n=36).

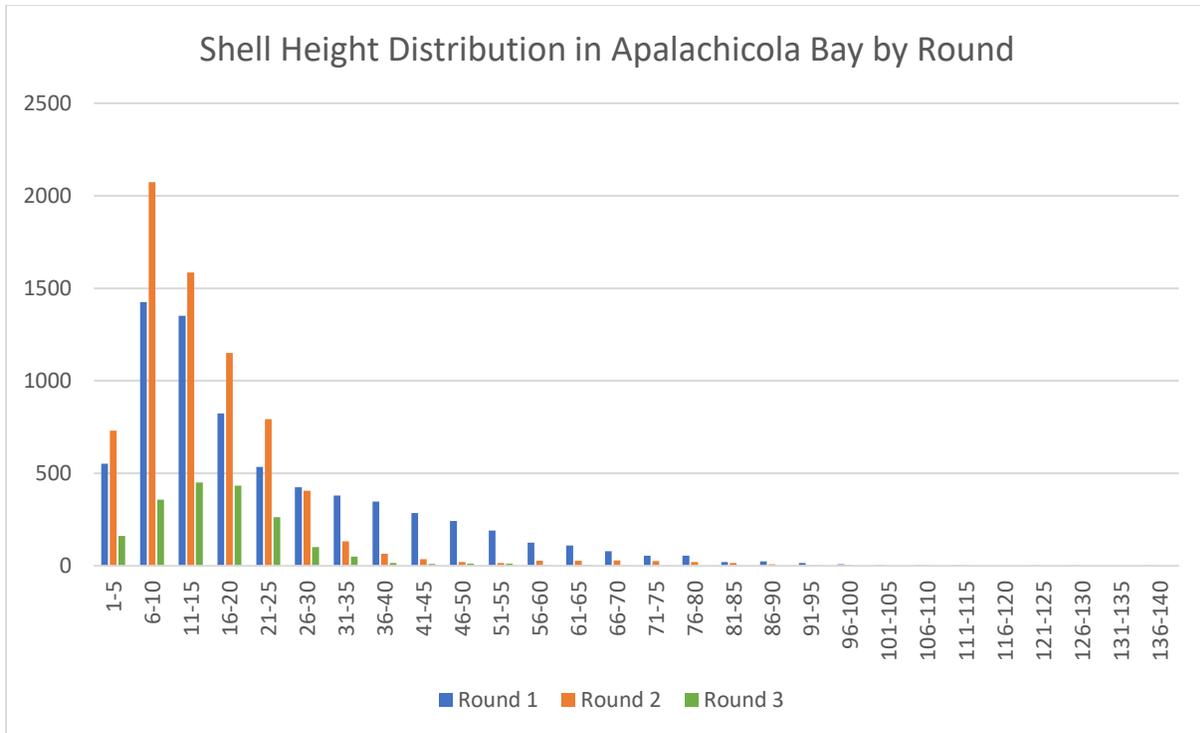
Figure 10: Shell height distribution by sampling round for the entire bay.

The average shell height for oysters collected in Apalachicola Bay in Rounds 1, 2, and 3 of sampling was 23.52 mm, 15.73 mm and 16.34 mm, respectively. The decrease in average shell height from Round 1 to Round 3 was found to be statistically significant ( $p=8.8 \times 10^{-112}$ ), as was the increase in average shell height from Round 2 to Round 3 ( $p=0.02$ ). All average shell heights are representative of the spat-sized oyster class (0-25mm). Shell height distribution of all measured oysters was plotted (Figure 10). A shell height of 11-15 mm was observed most frequently among live oysters collected in Apalachicola Bay in Round 3. Across all rounds, a shell height of 6-10 mm was most prevalent.

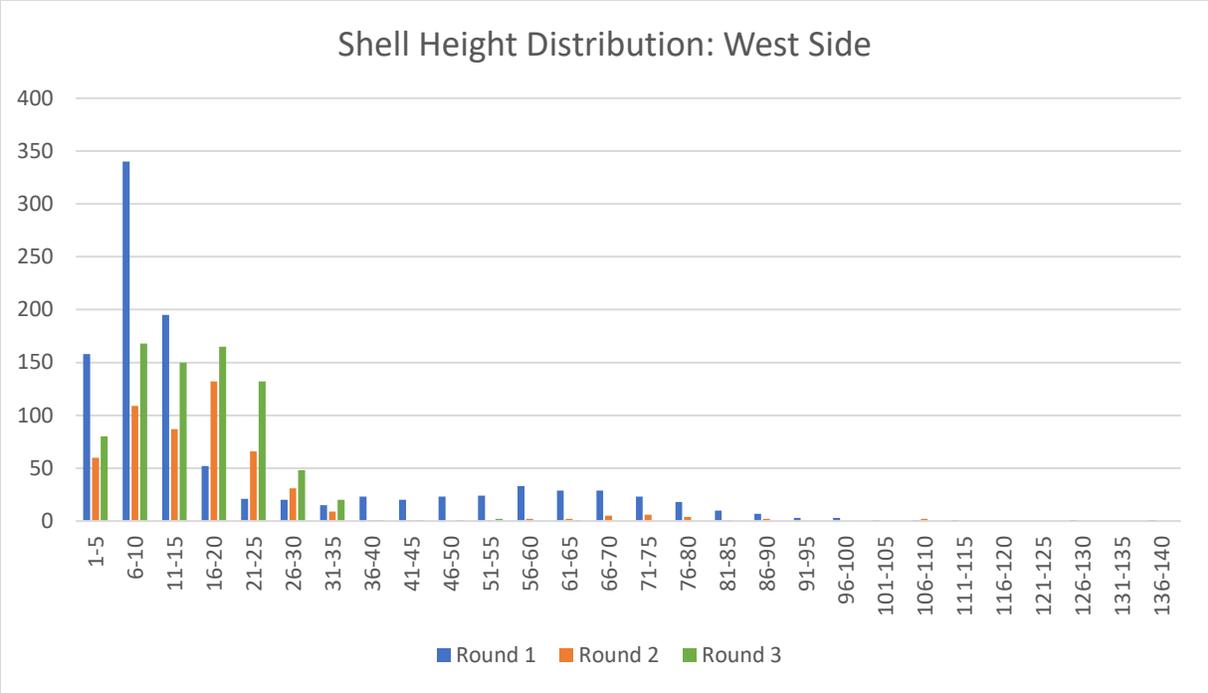
Figure 11: Shell height distribution by sampling round for the West side of the bay.

The shell height distributions of live oysters collected from both the West and East sides of Apalachicola Bay followed similar frequency distribution patterns to that of the entire bay (Figures 11 & 12). A shell height of 6-10 mm was observed most frequently among live oysters collected on the West side of the bay in Rounds 1 and 3, while oysters in the 16-20 mm shell height range were observed more frequently in Round 2 (Figure 11). To date, approximately 81.84% of all oysters measured on the West side of the bay have been in the spat size class. Oysters observed on the East side of the bay for Rounds 1 and 3 were most frequently observed in the 11-15 mm shell height range, while in Round 2 most live oysters occurred in the slightly smaller shell height range of 6-10 mm (Figure 12). The spat size class represents approximately 79.62% of all live oysters measured from the East side of the bay to date.

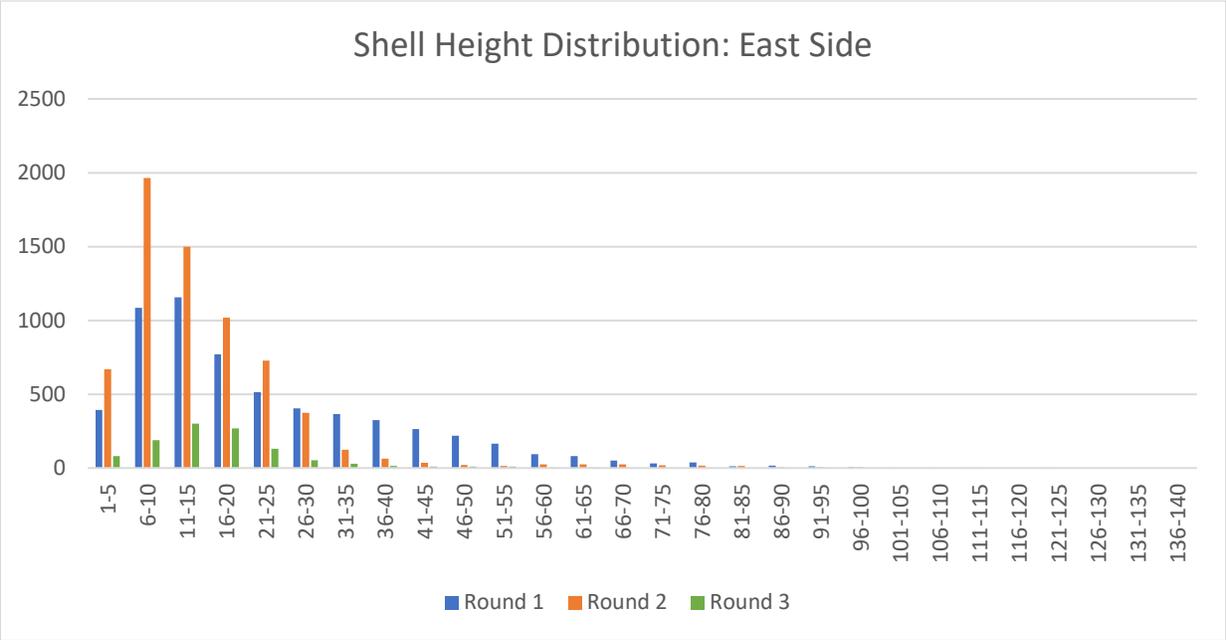
Figure 12: Shell height distribution by sampling round for the East side of bay.

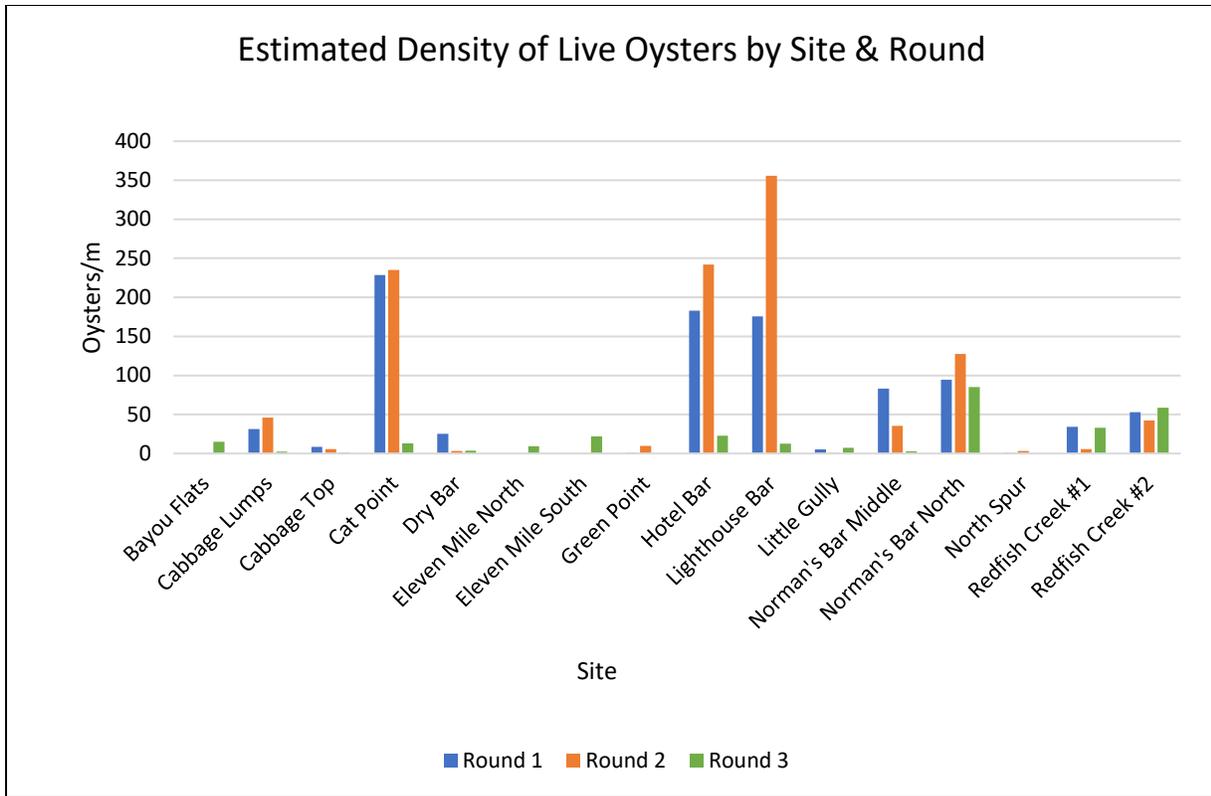
Figure 13: Estimated density of live oysters (oysters/m<sup>2</sup>) by site and sampling round.

The estimated density of live oysters varied greatly by site (Figure 13). Cat Point had the highest estimated oyster density during the first round of sampling ( $228.80$  live oysters/ $m^2$ ), while Lighthouse Bar had the highest for Round 2 ( $355.60$  oysters/ $m^2$ ). Norman's Bar North had the highest estimated oyster density ( $85.07$  live oysters/ $m^2$ ) for Round 3 of sampling, which is considerably less than the highest densities of previous rounds. A decline in estimated oyster density was observed at more than half of the sampling sites (Cabbage Lumps, Cabbage Top, Cat Point, Green Point, Hotel Bar, Lighthouse, Norman's Bar Middle, Norman's Bar North and North Spur) from Round 2 to Round 3. The greatest decline was observed at Lighthouse Bar, which decreased from  $355.60$  to  $12.53$  live oysters/ $m^2$  from Round 2 to Round 3.

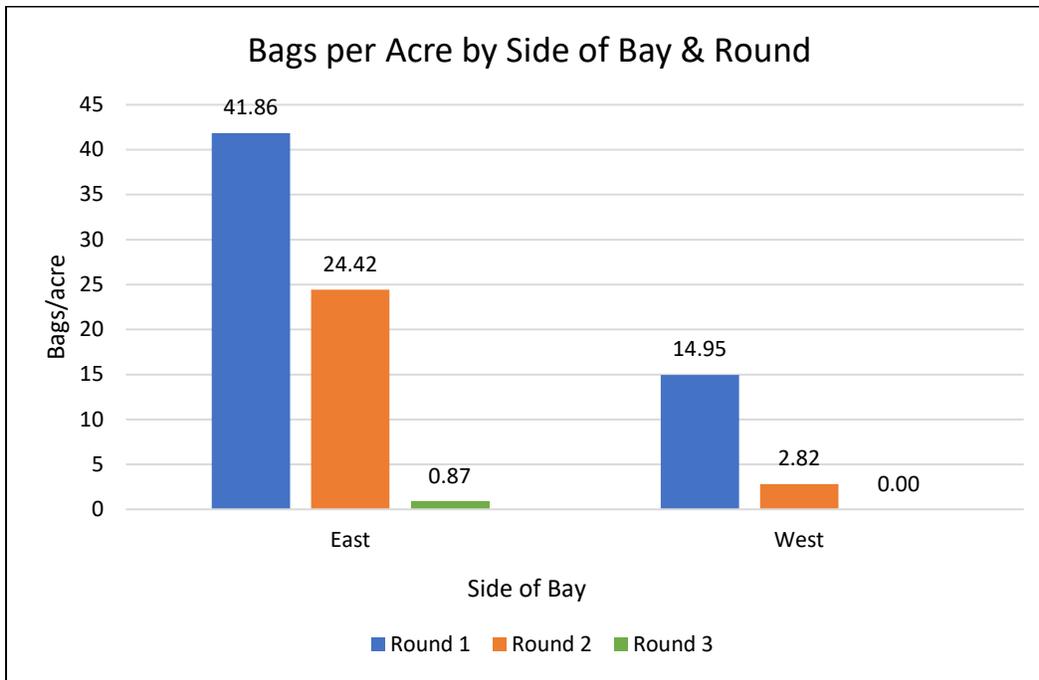
Figure 14: Estimated average bags per acre by side of bay and round.

It is evident that neither the East nor West side of the bay are capable of producing enough adult oysters to sustain commercial harvest (Figure 14). The number of bags per acre of harvestable oysters has decreased over time on both sides of the bay. The estimated number of harvestable oysters on the East side of the bay, which has historically been more productive, has decreased by approximately 98% at cultched sites since the beginning of project sampling.

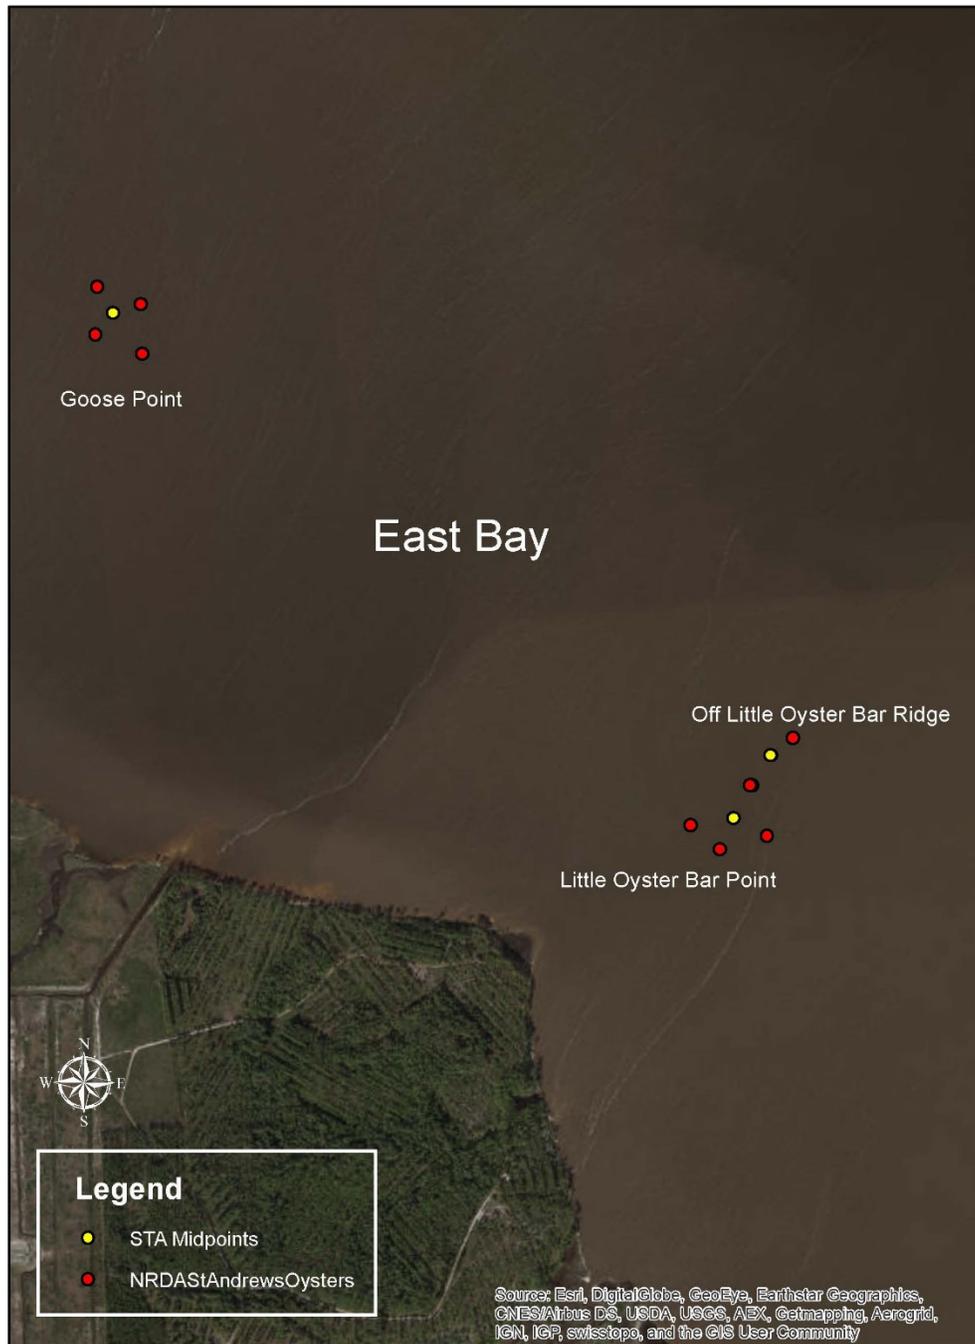
Figure 18: NRDA sites and midpoints in East Bay.

East Bay (Figure 18):

- Off Little Oyster Bar Ridge: A natural oyster reef ridge to the north and east of Little Oyster Bar Point in East Bay. The surrounding bottom is generally muddy. This site has one midpoint to monitor.

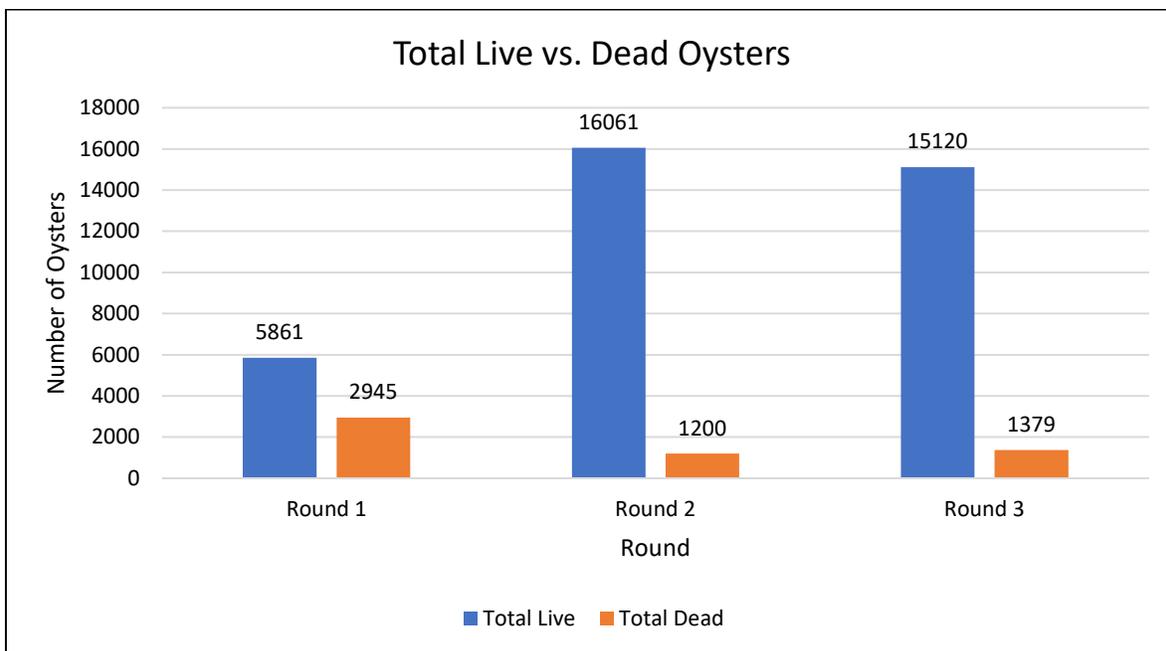
Figure 19: Total live and dead oysters collected in St. Andrews Bay system.

To date, a total of 37,042 live oysters and 5,524 dead oysters have been sampled from St. Andrews Bay. In Round 3, 15,120 live oysters and 1379 dead oysters were observed. The increase in number of live oysters and decrease in dead oysters from Round 1 to Round 3 were found to be statistically significant ( $p=6.00 \times 10^{-5}$  and  $p=6.80 \times 10^{-6}$ , respectively.) Although a decrease in live oysters and increase in dead oysters was observed from Round 2 to Round 3, these differences were not found to be statistically significant ( $p=0.68$  and  $p=0.25$ , respectively). The number of live and dead oysters sampled by round can be seen in Figure 19.

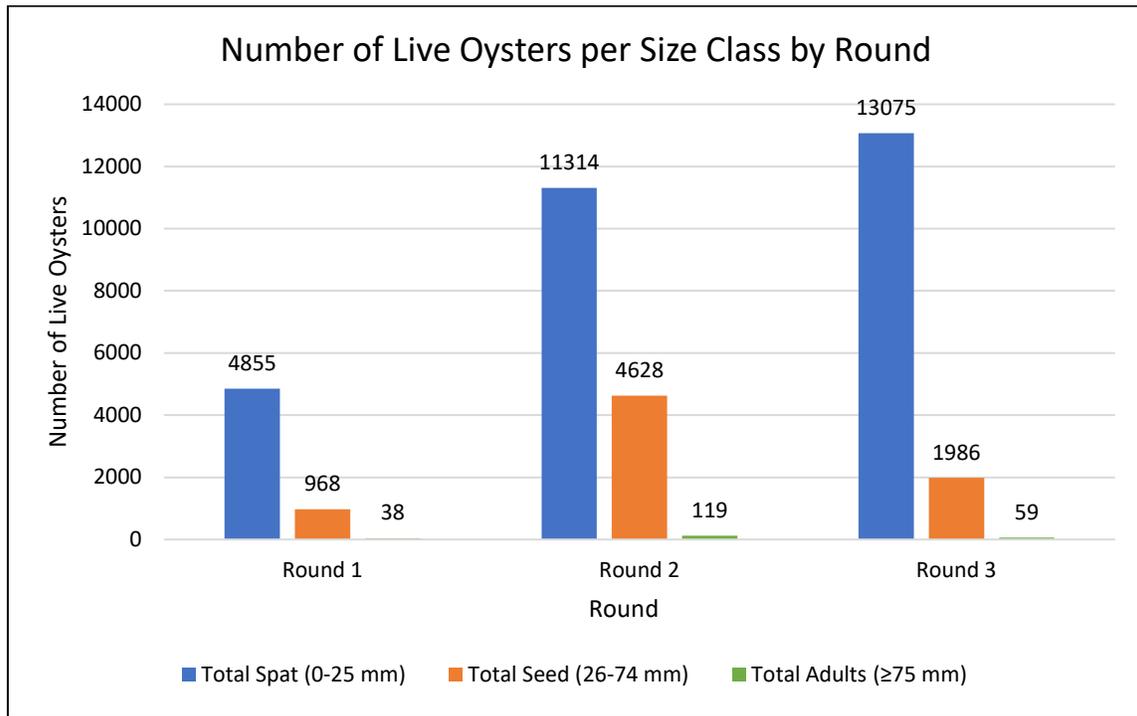
Figure 20: Size class distribution for St. Andrews Bay.

A comparison of oyster abundance by size-class shows that in Round 3, spat sized oysters continued to be the most abundant ( $n=13,075$ ), followed by seed-sized oysters ( $n=1,986$ ) and adult-sized, harvestable oysters ( $n=59$ ). An increase in spat-sized oysters was observed from Round 1 ( $n=4,855$ ) to Round 3 and from Round 2 ( $n=11,314$ ) to Round 3. When analyzed on a per sample basis, the increase in number of spat from Round 1 to Round 3 was found to be statistically significant ( $p=0.0002$ ), but the increase from Round 2 to Round 3 was not ( $p=0.41$ ). An increase in the number of seed-sized oysters was observed from Round 1 ( $n=968$ ) to Round 3, but a decrease in the same size class was observed from Round 2 ( $n=4,628$ ) to Round 3. Both the increase from Round 1 to Round 3 and the decrease from Round 2 to Round 3 were found to be statistically significant ( $p=1.2 \times 10^{-5}$  and  $4.5 \times 10^{-8}$ , respectively). The same pattern was observed in oysters of the adult size class; an increase in adult-sized oysters was observed from Round 1 ( $n=38$ ) to Round 3, but a decrease was observed from Round 2 ( $n=119$ ) to Round 3. The

increase in adult oysters from Round 1 to Round 3 was not found to be statistically significant ( $p=0.31$ ), but the decrease from Round 2 to Round 3 was considered significant ( $p=0.02$ ) (Figure 20).

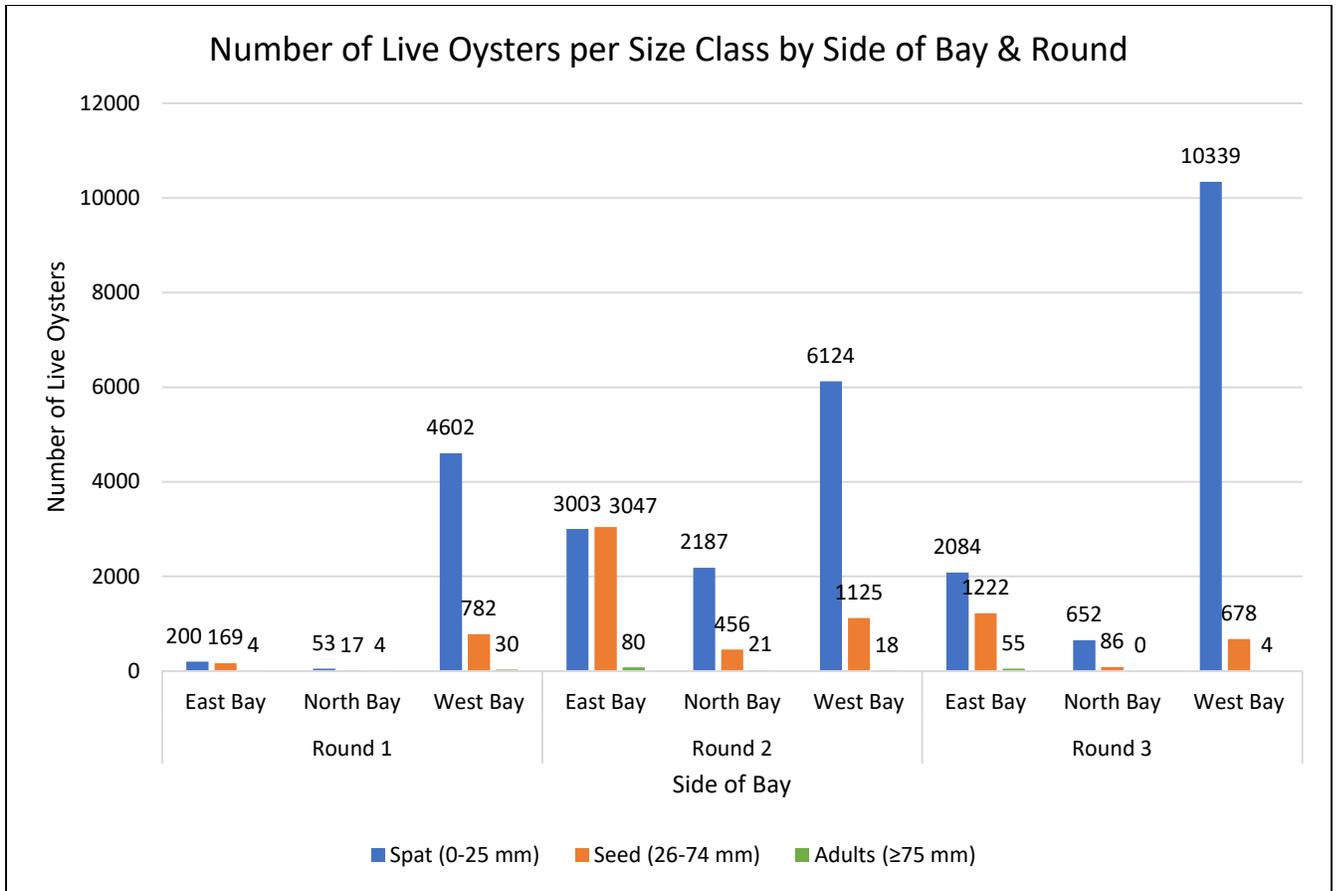
Figure 21: Size class distribution of live oysters within the three geographically distinct bays.

The St. Andrews Bay system contains four geographically distinct bays: St. Andrew Bay, West Bay, North Bay, and East Bay (Figure 15). Sample sites in West Bay include Crooked Creek Point, Doyle Bayou, South Channel Ridge, and West Bay Point. East of Power Lines and Newman Bayou Bar are the only monitoring sites in North Bay. East Bay contains three sampling sites: Off Little Oyster Bar Ridge, Little Oyster Bar Point and Goose Point. There are no oyster cultch sites in St. Andrew Bay proper. Data was analyzed by geographic region (i.e. Bay) to account for regional differences in oyster populations. To date, West Bay has continued to produce the highest total number of live oysters, as well as the highest number of spat-sized oysters. In West Bay, an increase in the number of spat sampled was observed from Round 1 ( $n=4,602$ ) to Round 3 ( $n=10,339$ ) and from Round 2 ( $n=6,124$ ) to Round 3. However, decreases in seed-sized and adult-sized oysters were observed from Round 1 to Round 3 and Round 2 to Round 3 in West Bay. In East Bay, increases in live oysters were observed across all size classes from Round 1 to Round 3, but decreases across all size classes were observed from Round 2 to Round 3. In North Bay, increases in spat- and seed-sized oysters were observed from Round 1 ( $n=53$  spat and  $n=17$  seed) to Round 3 ( $n=652$  spat and  $n=86$  seed), and a decrease in adult-sized oysters was observed ( $n=4$  and  $n=0$ , respectively). North Bay has historically produced fewer live oysters than the rest of the geographic regions sampled in St. Andrews Bay. From Round 2 to Round 3, decreases in number of live oysters were observed across all size classes in North Bay (Figure 21).

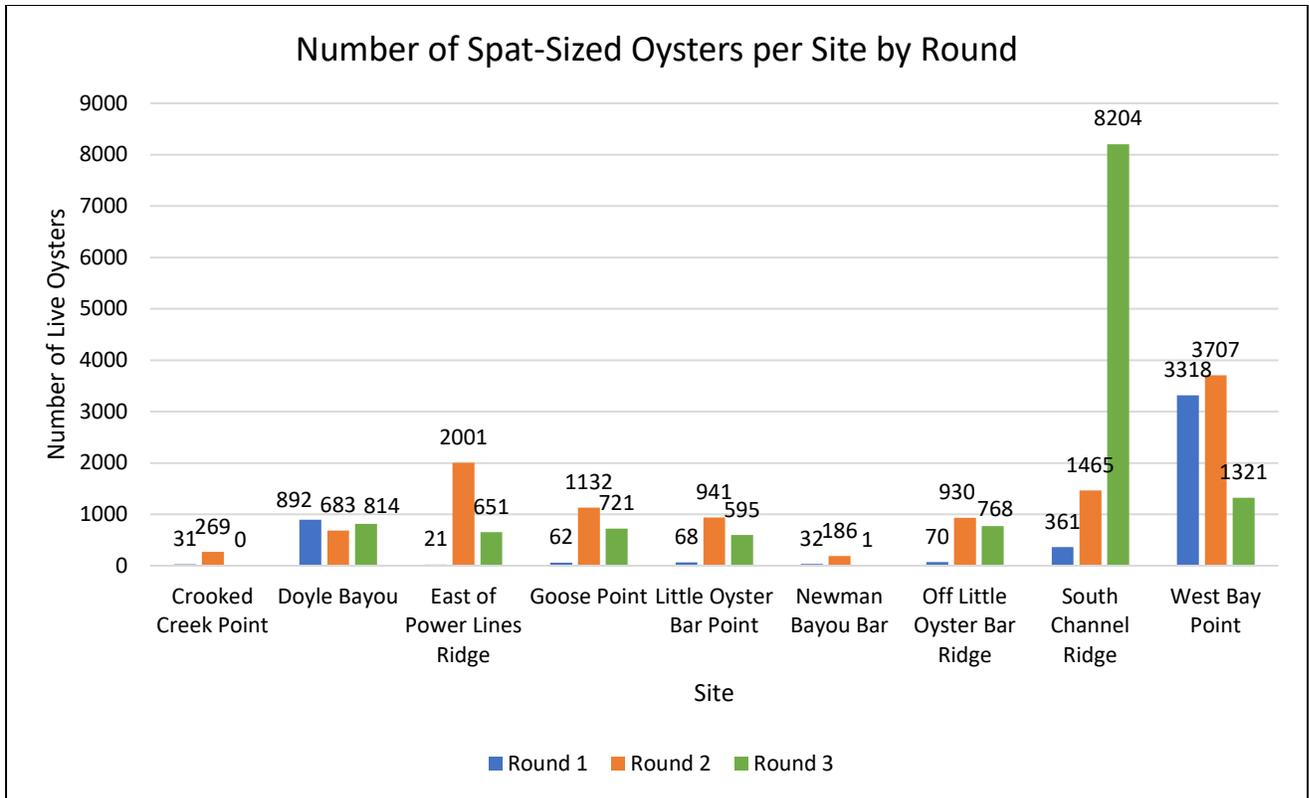
Figure 22: Spat size class distribution by site and round of sampling.

When comparing size class distribution by site, a decrease in the number of spat-sized oysters was observed from Round 2 to Round 3 at all sites except for Doyle Bayou and South Channel Ridge. South Channel Ridge experienced a dramatic increase in the number of spat sampled from Round 2 to Round 3 (n=1,465 and n=8,204, respectively). The number of spat observed at South Channel Ridge accounted for approximately 62.75% of the total spat sampled during Round 3. From Round 1 to Round 3, approximately half of all sites experienced a decrease in spat-sized oysters sampled, and half experienced an increase. Zero spat-sized oysters were observed at Crooked Creek Point in Round 3, and only one was observed at Newman Bayou Bar (Figure 22).

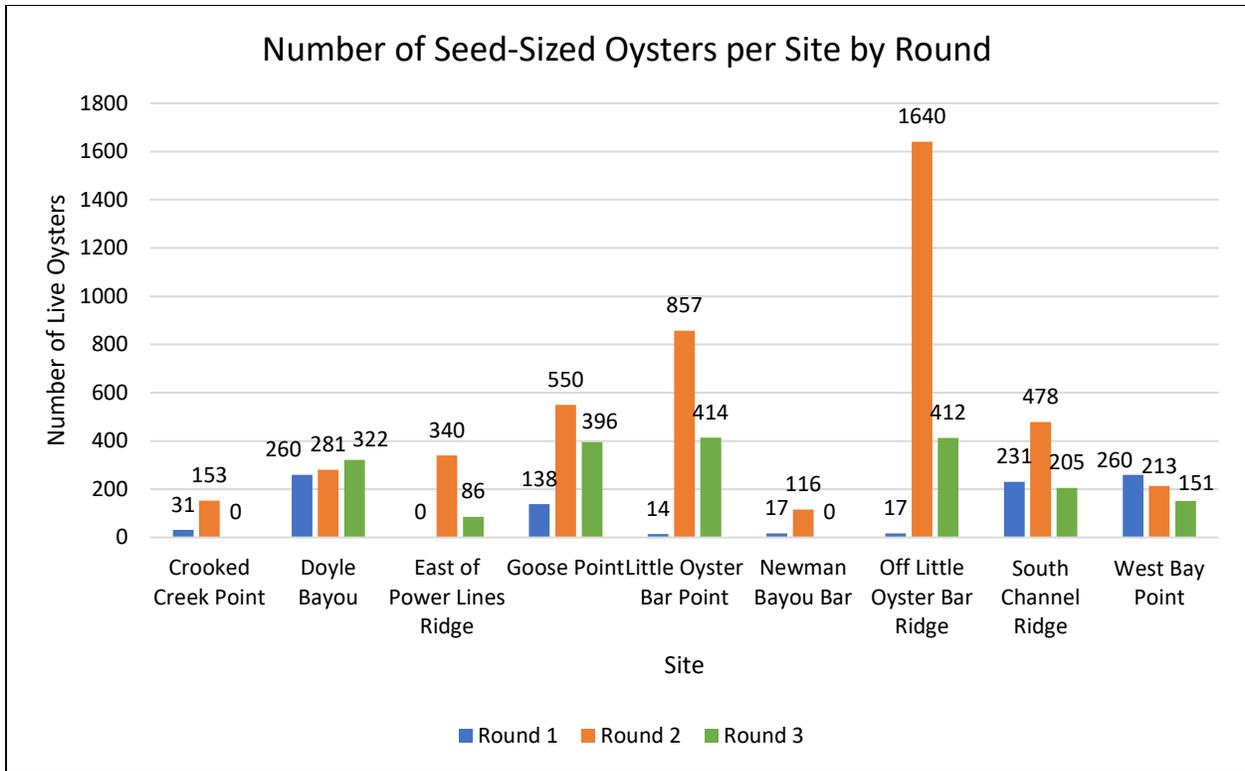
Figure 23: Seed size class distribution by site and round of sampling.

Except for Doyle Bayou, all sites experienced a decrease in the number of seed-sized oysters sampled from Round 2 to Round 3. The highest number of seed-sized oysters observed during Round 3 was at Little Oyster Bar Point (n=414), which is a dramatic decrease in the highest number of seed observed in Round 2 (Off Little Oyster Bar Ridge, n=1,640). Zero seed-sized oysters were observed at Crooked Creek Point and at Newman Bayou Bar in Round 3. As was seen in spat-sized oysters, approximately half of sites experienced a decrease from Round 1 to Round 3 in the number of seed-sized oysters sampled, and approximately half experienced an increase. (Figure 23).

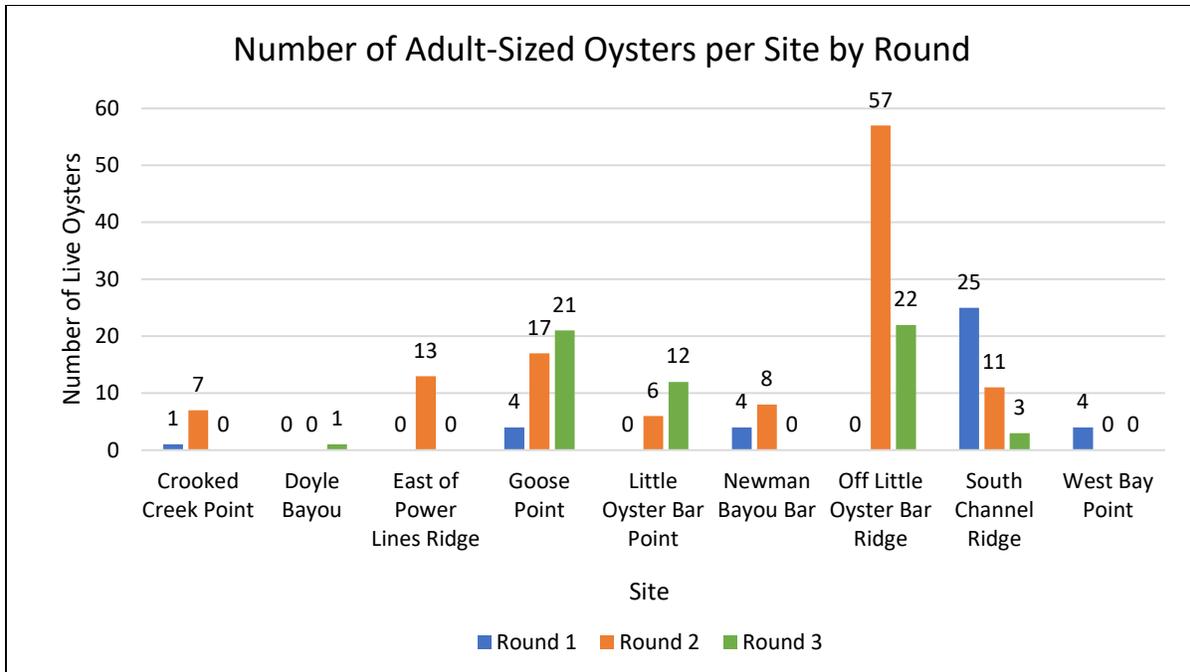
Figure 24: Adult size class distribution by site and round of sampling.

While the number of adult-sized oysters has remained relatively low throughout all rounds of sampling, increases in adult-sized oysters were only observed at three sites from Round 2 to Round 3: Doyle Bayou (n=1), Goose Point (n=21), and Little Oyster Bar Point (n=12). West Bay Point had zero adult oysters present in both Round 2 and Round 3, and all other sites experienced a decrease in the number of adult oysters from Round 2 to Round 3. As was noted in other size classes, approximately half of the sites in St. Andrews Bay experienced an increase in the number of adult-sized oysters sampled, while approximately half saw a decrease. Zero adult-sized oysters were observed at East of Power Lines Ridge in both Round 1 and Round 3 (Figure 24).
