# Florida Oyster Cultch Placement Project

## Year Two Monitoring Report

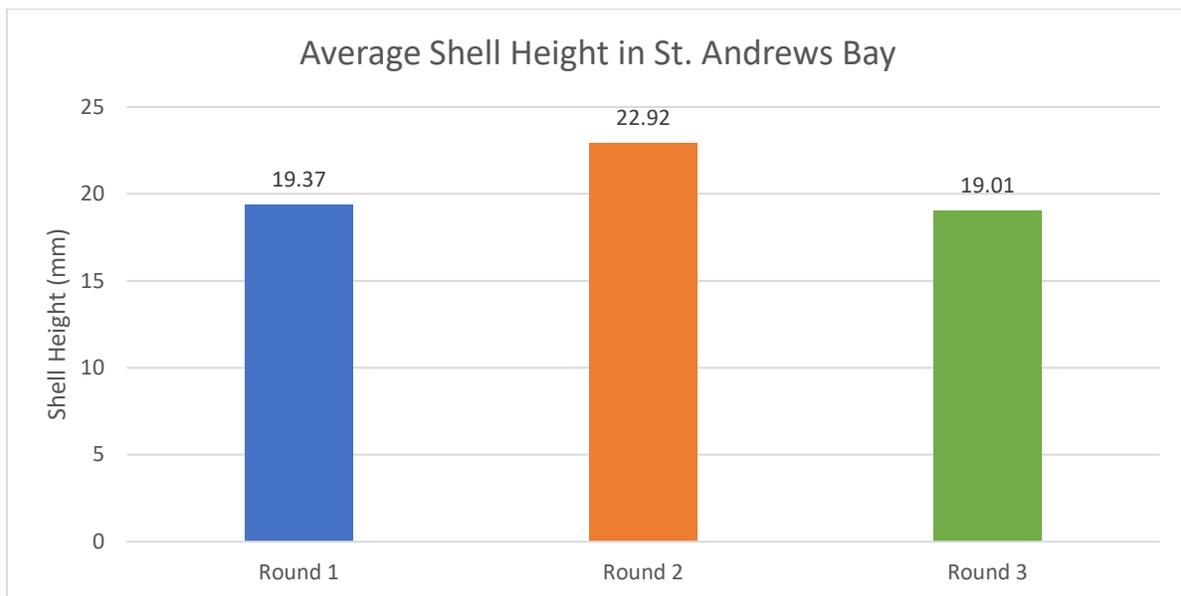
Figure 25: Average shell height of live oysters collected in the St. Andrews Bay system.

Average shell height of all oysters sampled in St. Andrews Bay during Round 3 was 19.01 mm (Figure 25). Statistical analysis showed that the average shell height observed in Round 3 was not significantly less than that of Round 1 ( $n=19.37\text{mm}$ ,  $p=0.22$ ), but was considered significantly less than the average shell height in Round 2 ( $n=22.92$ ,  $p=5.9 \times 10^{-76}$ ).

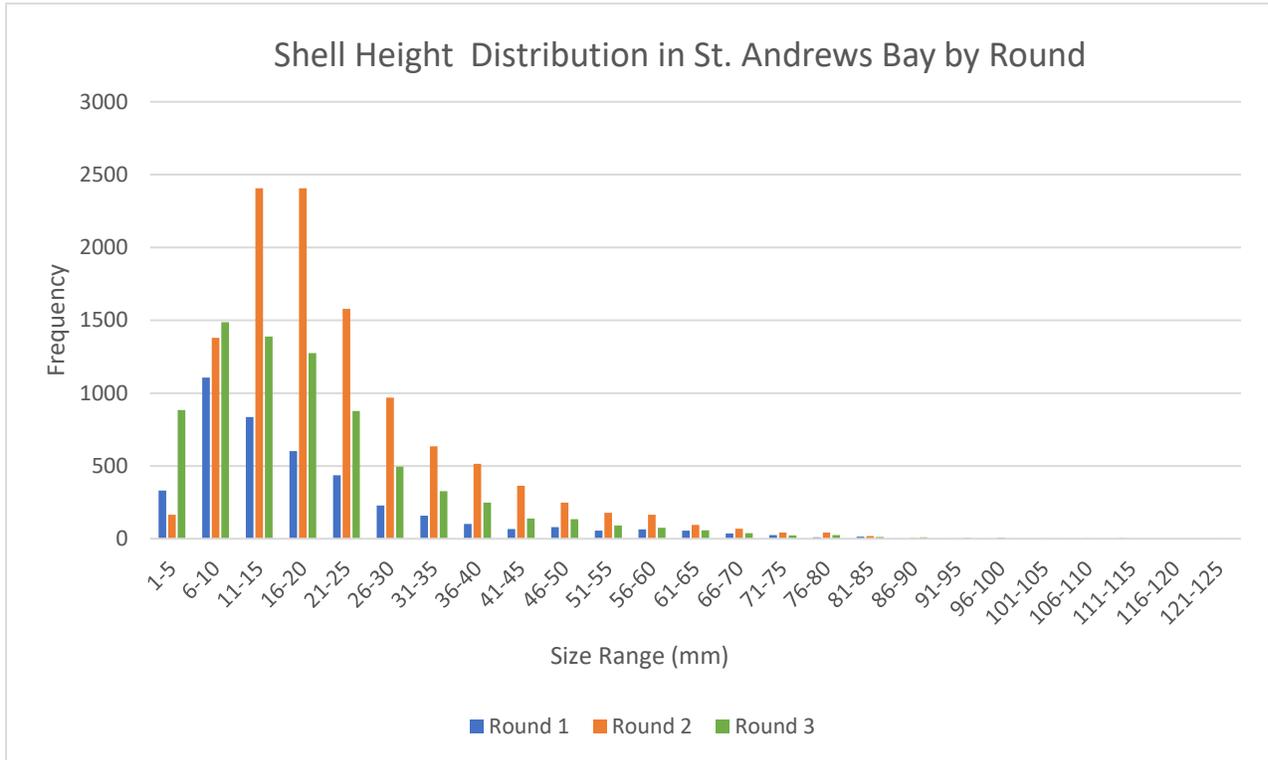
Figure 26: Shell height distribution throughout the entire bay system.

sized); the most prevalent shell height range was 6-15mm in Rounds 1 and 3, and 11-20 mm in Round 2 (Figure 26). The size frequency distribution was similar across all rounds, with a higher frequency of oysters in the spat- and seed-sized ranges, although Round 2 contained a greater number of oysters in the 11-25 mm range than Rounds 1 and 3.

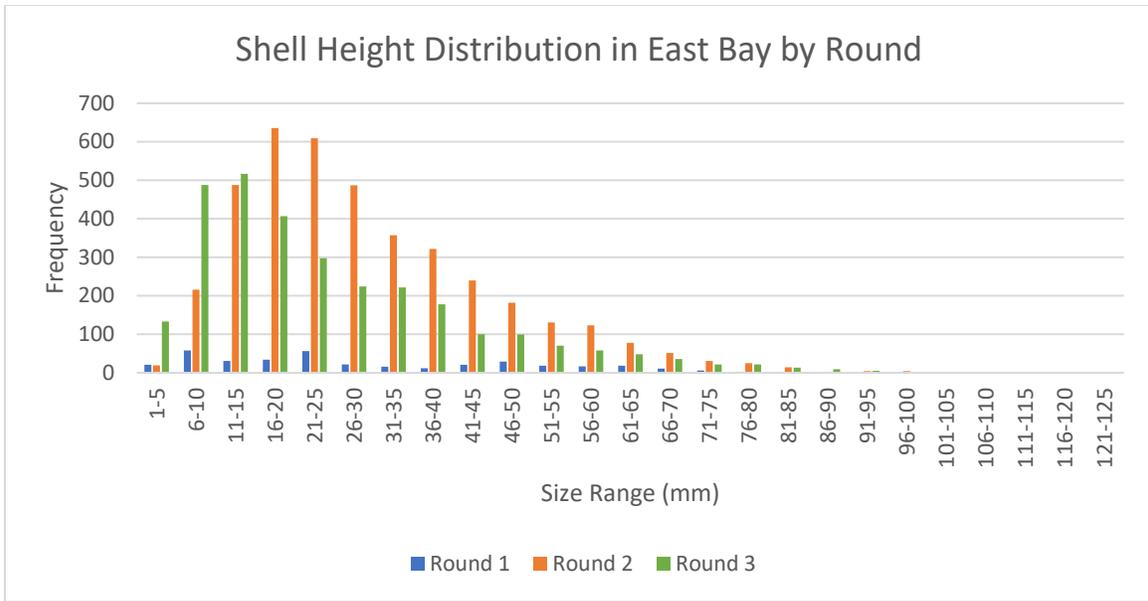
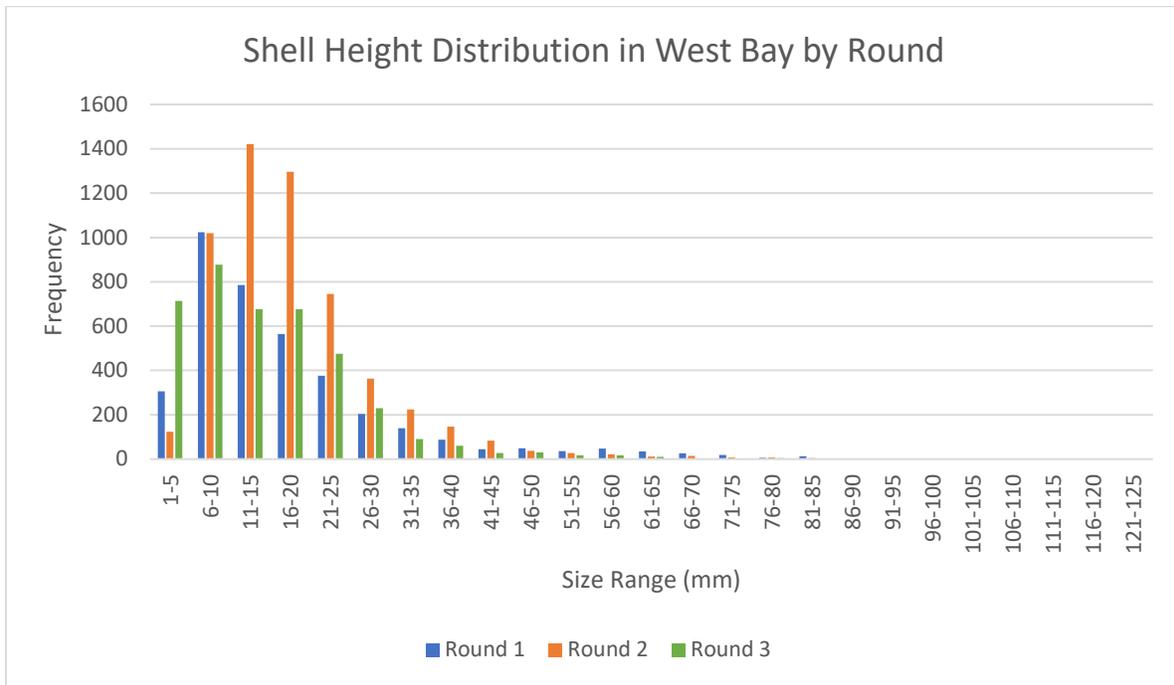
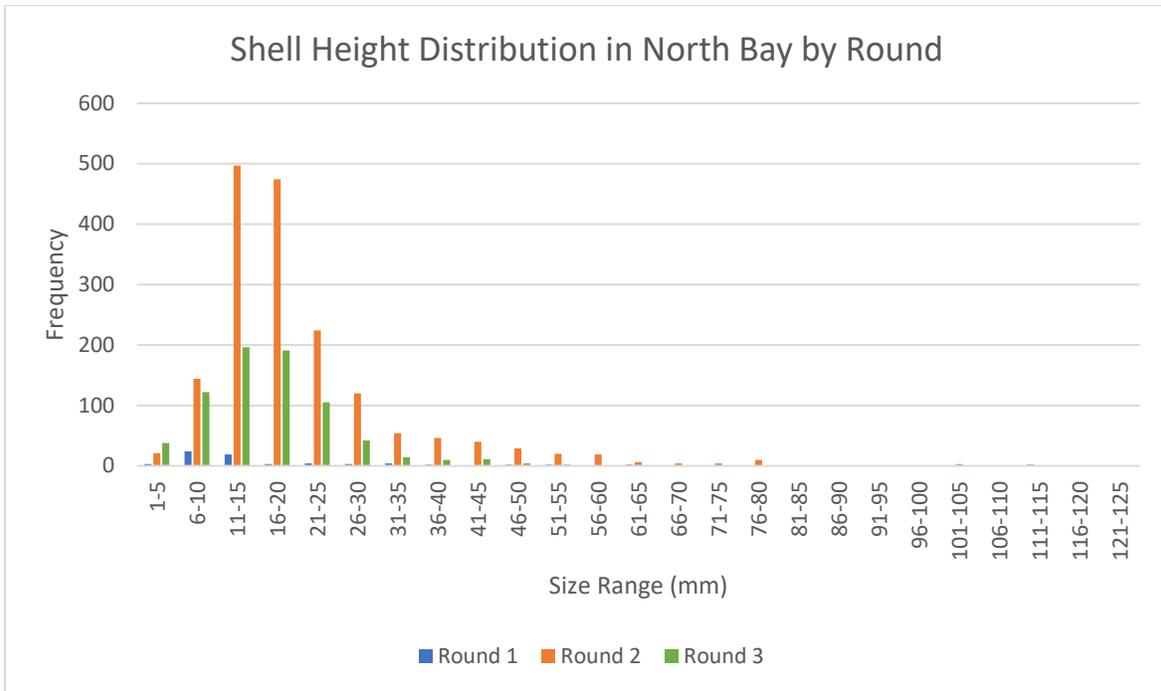
Figure 27: Shell height distribution in East Bay.

Figure 28: Shell height distribution in West Bay.

Figure 29: Shell height distribution in North Bay.

Shell height distribution in each individual bay was similar to that of the entire St. Andrews Bay system. In East Bay, the most prevalent size range in Round 3 was 6-20mm, whereas the most prevalent size range in Round 2 was 11-25mm. In West Bay, the most frequently observed size range was slightly smaller than that of East Bay; the most prevalent size range in Round 3 was 1-15mm in West Bay. This is also slightly smaller than previous rounds, with 6-20mm as the most prevalent size range in Round 1 and Round 2 in West Bay. Although drastically fewer oysters were sampled in North Bay from Round 2 to Round 3, oysters of the 6-25mm range remained the most prevalent. Shell height measurements from North Bay in Round 1 also trended toward a smaller size range (6-15mm), with very few observations made in Round 1 compared to Rounds 2 and 3 (Figures 27-29).

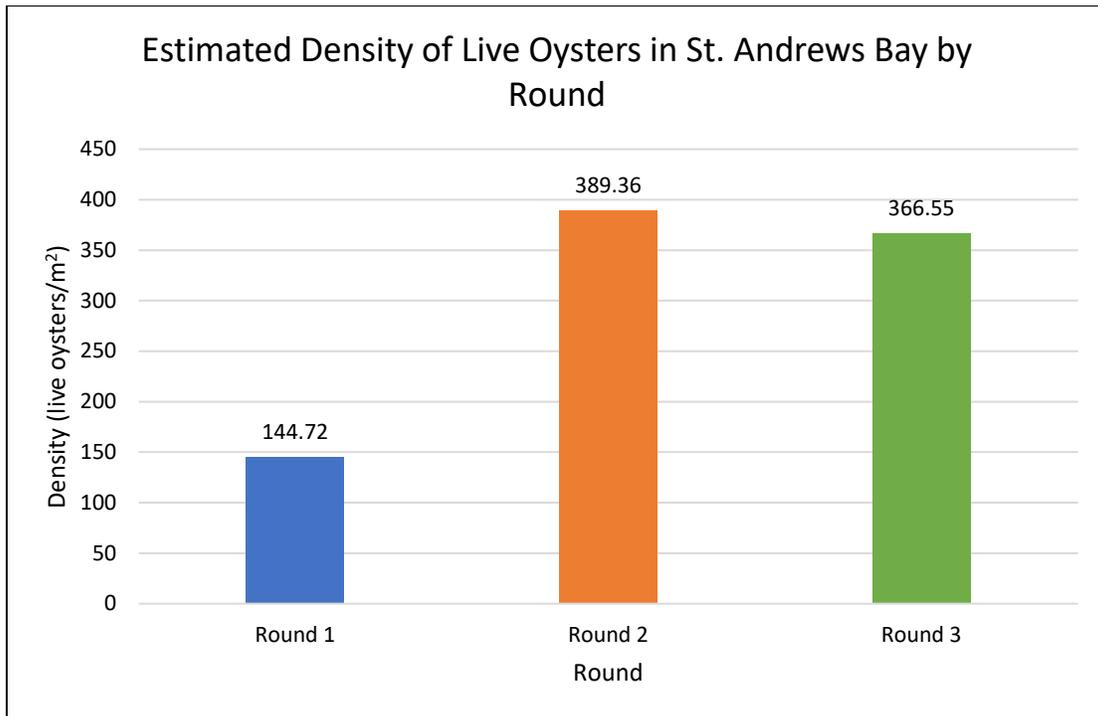
Figure 30: Density of live oysters in St. Andrews Bay by round.

The estimated density of live oysters for all restored reefs in the St. Andrews Bay system was 366.55 live oysters/m<sup>2</sup> in Round 3. This is more than double the estimated density of Round 1 (n=144.72 live oysters/m<sup>2</sup>), and slightly less than the estimated density of Round 2 (n=389.36 live oysters/m<sup>2</sup>) (Figure 30).

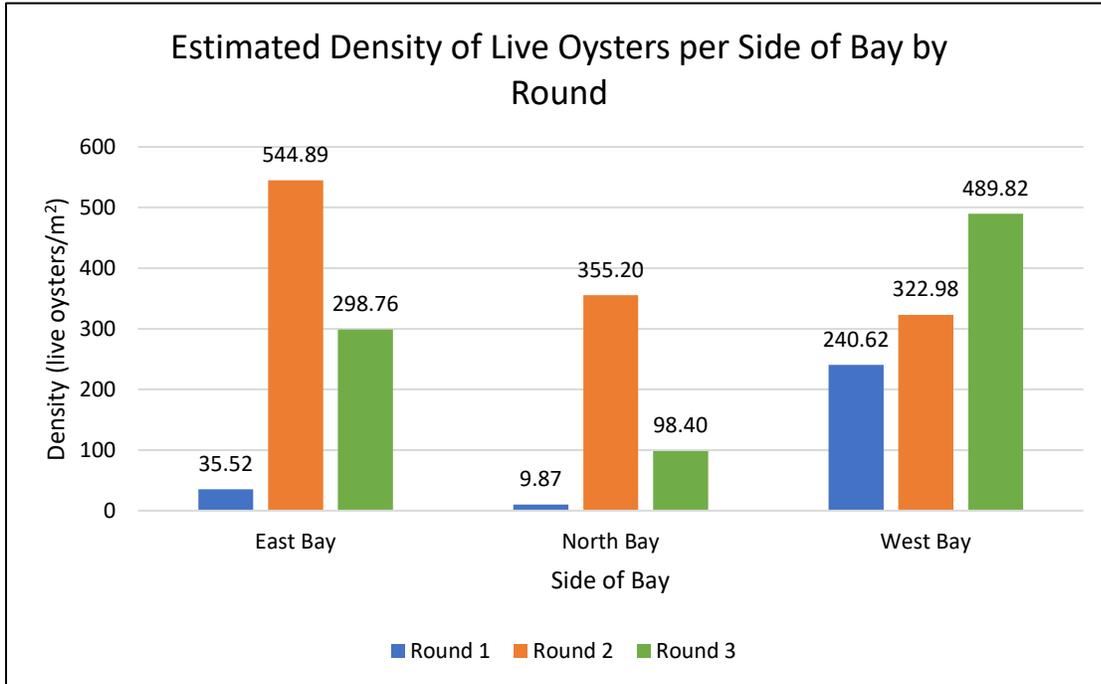
Figure 31: Density of live oysters in St. Andrews Bay by round of sampling.

When compared by side of bay, the estimated density of live oysters increased from Round 1 to Round 2 but decreased from Round 2 to Round 3 in both North Bay and East Bay. A steady increase in estimated live oyster density was observed from Round 1 and Round 2 to Round 3 in West Bay, with an increase of approximately 150% from Round 2 (n=322.98) to Round 3 (n=489.82) (Figure 31).

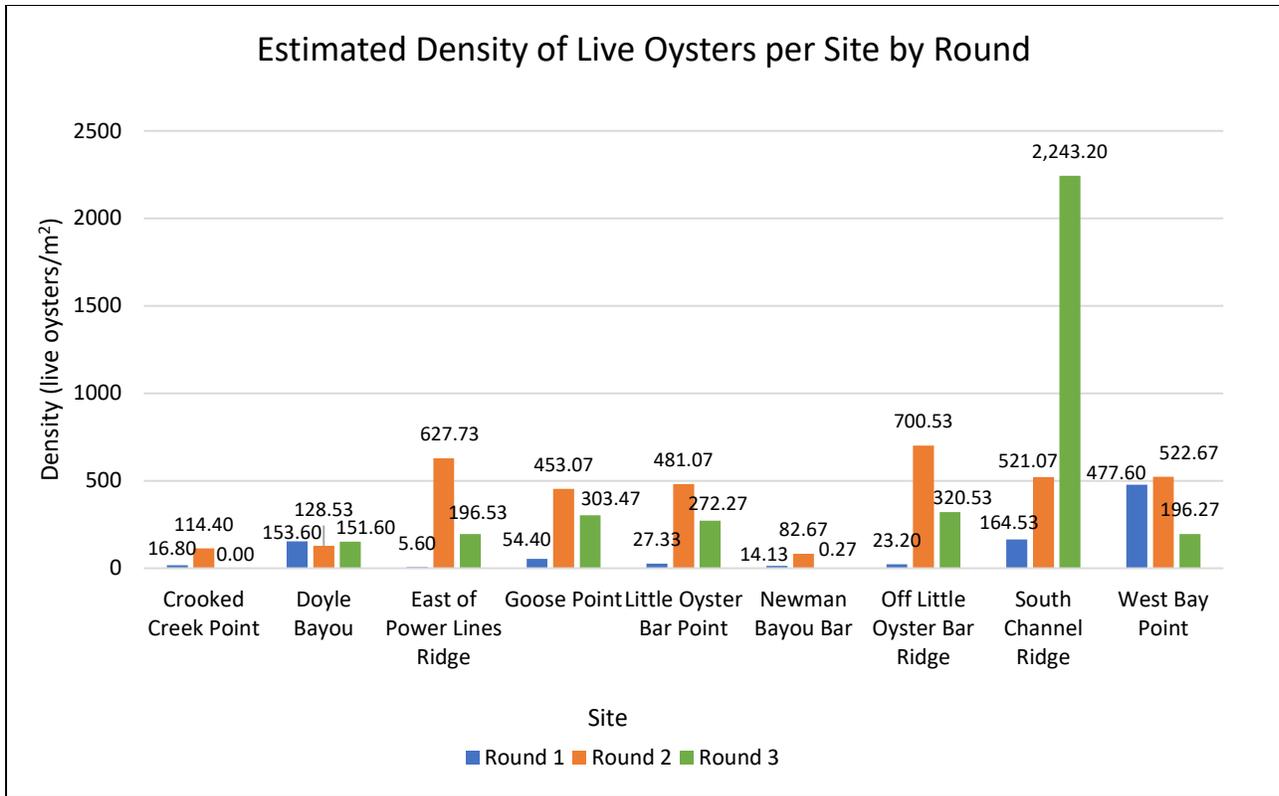
Figure 32: Density of live oysters collected throughout the bay during each round of sampling.

Decreases in live oyster density were observed at all sites from Round 2 to Round 3, with the exceptions of Doyle Bayou and South Channel Ridge. South Channel Ridge had the highest estimated live oyster density in Round 3 (n=2,243.20 live oysters/m<sup>2</sup>). From Round 1 to Round 3, approximately half of sites experienced a decrease in estimated live oyster density, while half experienced an increase (Figure 32).

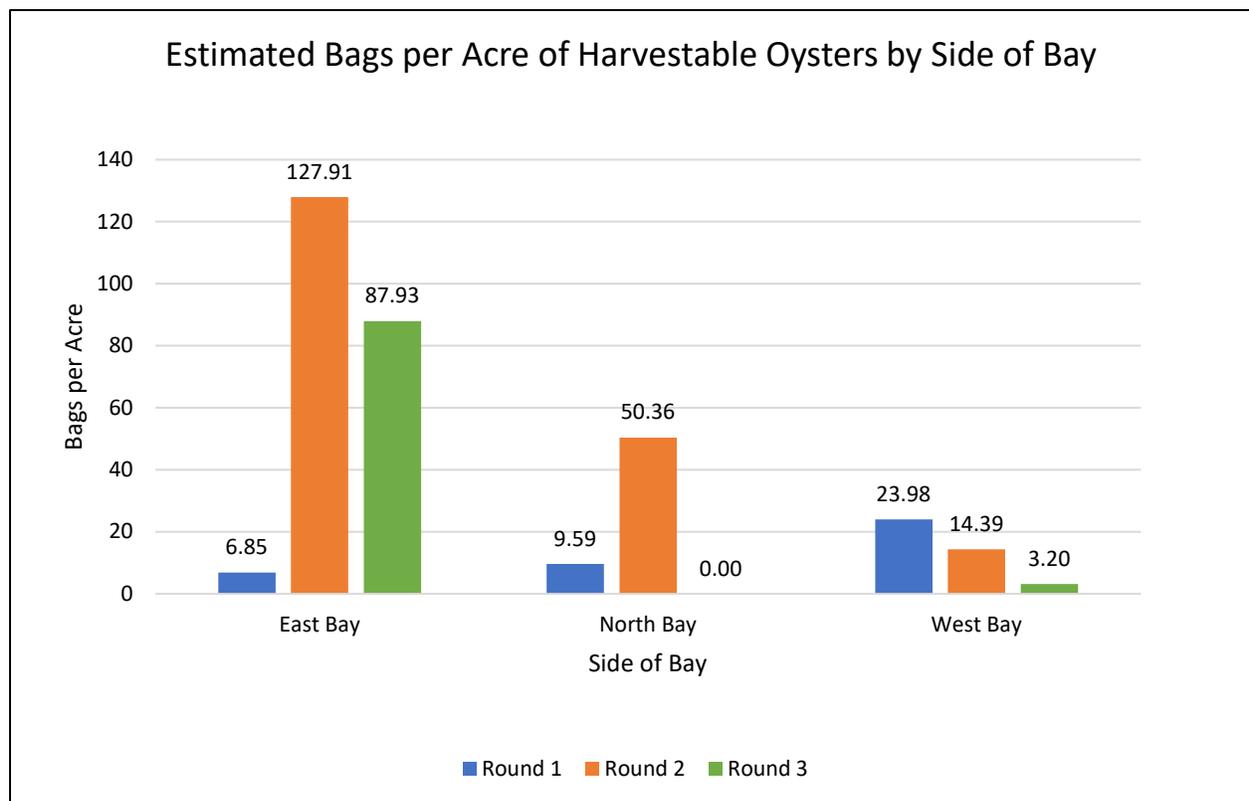
Figure 33: Estimated average bags per acre of harvestable oysters by side of bay.

It is evident that all reefs have estimates that would be considered below the level necessary to support commercial harvest (<200 bags per acre) or depleted (<100 bags/acre). All bays experienced a decrease in estimated bags per acre of harvestable oysters from Round 2 to Round 3. Overall decreases from Round 1 to Round 3 were also observed in North Bay and West Bay. Zero bags per acre were estimated in North Bay in Round 3. However, an increase was seen in East Bay from Round 1 to Round 3 (Figure 33).

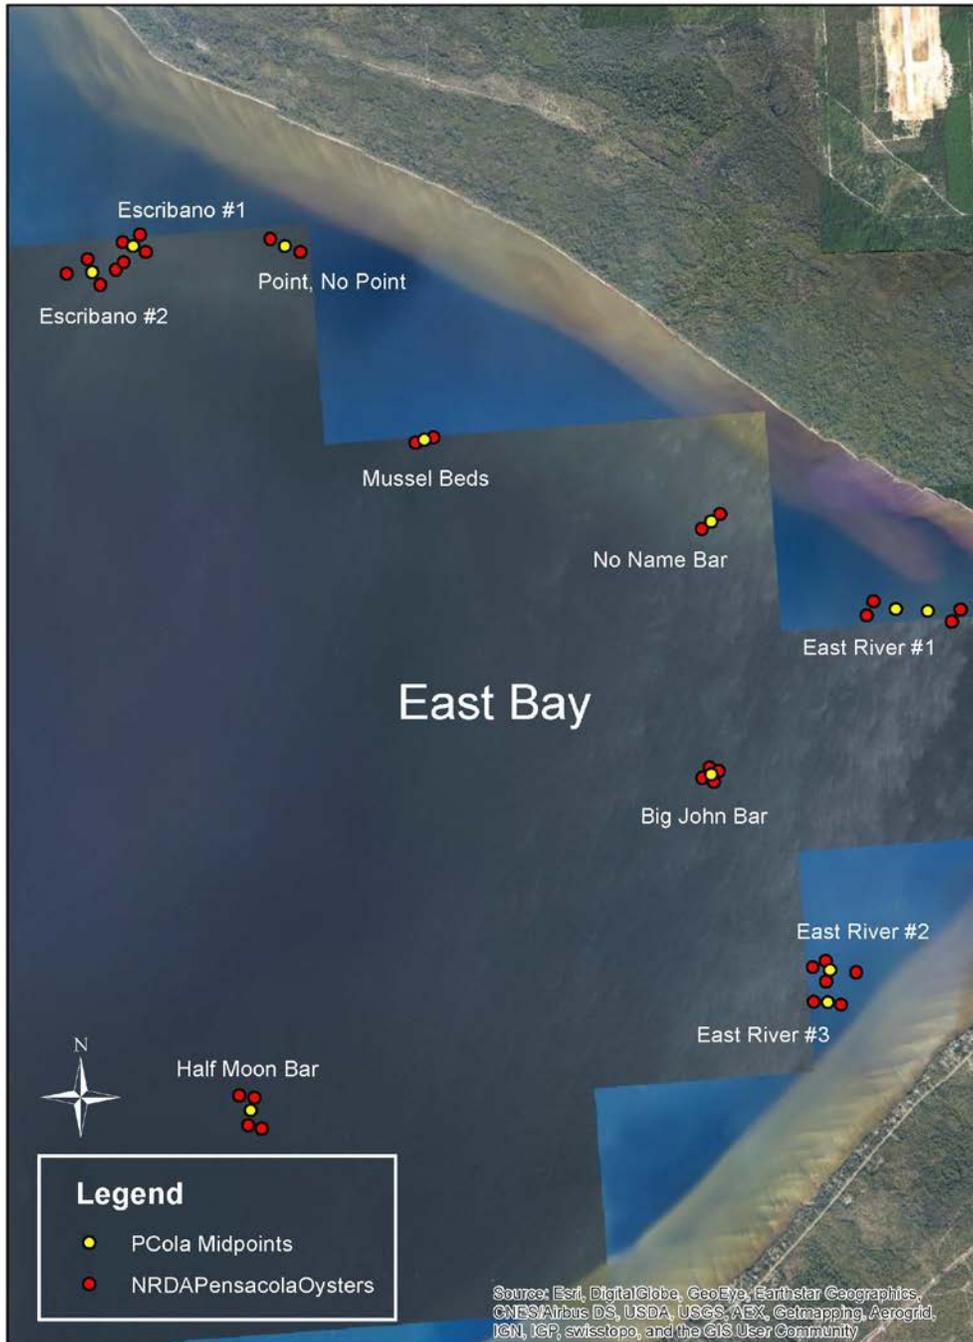
Figure 36: Map of Sample Sites in East Bay region of Pensacola Bay.

The Pensacola Bay watershed is an interconnected system of estuaries encompassing nearly 7,000 square miles in northwest Florida and southern Alabama, with approximately one third of the watershed residing within the state of Florida. The system is comprised of Escambia Bay, Pensacola Bay, Blackwater Bay, East Bay, and Santa Rosa Sound. Feeding into this series of embayments are three major rivers: the Escambia, Blackwater, and Yellow rivers. The East Bay River also contributes a small amount of freshwater to the system. The entirety of the Pensacola Bay watershed system eventually discharges into the Gulf of Mexico, south of Pensacola, Florida (Lewis, 2010). In October 2016, 20,103 cubic yards of a lime rock aggregate over an estimated 88 acres of debilitated oyster reefs in the Pensacola Bay System in Escambia and Santa Rosa Counties (FDACS, 2016). The following sites were selected for restoration, with monitoring conducted at the predetermined midpoints of each site (see Figure 34 and Table 10). Four of the sites sampled lie in the Escambia Bay region, with the remaining thirteen sites located within the East Bay region (refer to Figures 35 & 36 and Table 10).

### East Bay (Figure 36)

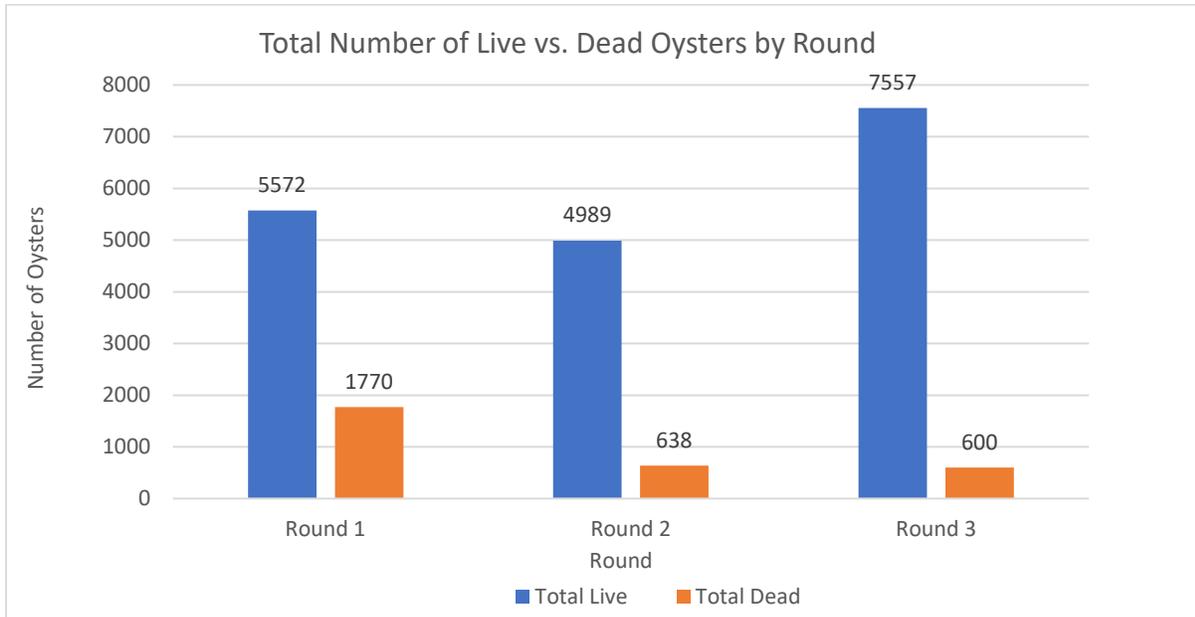
Figure 37: Total number of live vs. dead oysters sampled in Pensacola Bay by round.

statistically significant when analyzed on a per sample basis ( $p=0.002$  and  $p=2.92 \times 10^{-7}$ , respectively). The decrease in dead oysters sampled from Round 1 ( $n=1,770$ ) to Round 3 was found to be statistically significant ( $p=3.34 \times 10^{-9}$ ), but the decrease from Round 2 ( $n=638$ ) to Round 3 was not ( $p=.705$ ).
